## MICRO-ANALYSIS ON THE INTERNAL STRUCTURE OF FIBRE-SOIL COMPOSITE

Humphrey Danso

### Abstract

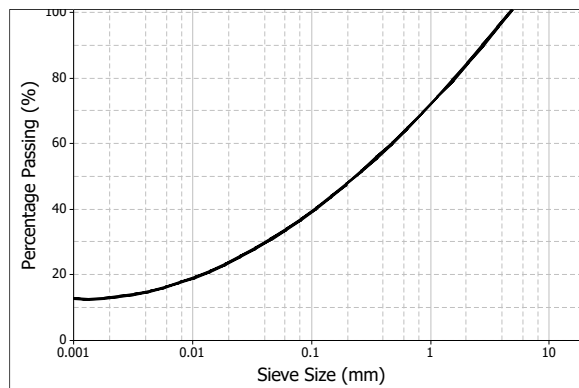
density (MDD) of the soil sample are 11.8% and  $1.83\text{Mg/m}^3$ , respectively. The particle size distribution (grading) of the soil is presented in Fig. 1. The liquid limit, plastic limit and plasticity index of the soil are 31.7(%), 18.9(%) and 13.7(%) respectively.

Fig. 1: Particle size distribution of the soil sample

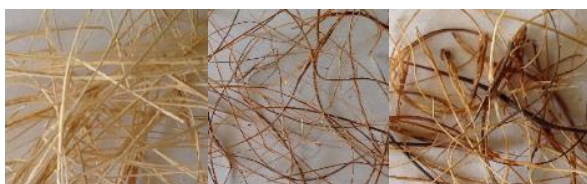
Fibres were obtained from three different agricultural wastes (sugarcane residue 'bagasse', coconut husk and oil palm fruit residue) in Ghana. Tab. 1 shows the lengths and diameters of one hundred each of coconut, oil palm and bagasse fibres. Fig. 2 shows the images of the fibres. Tap water from the civil engineering laboratory of University of Portsmouth, UK was used for making the blocks.

Fig 2: Photographs of the fibres

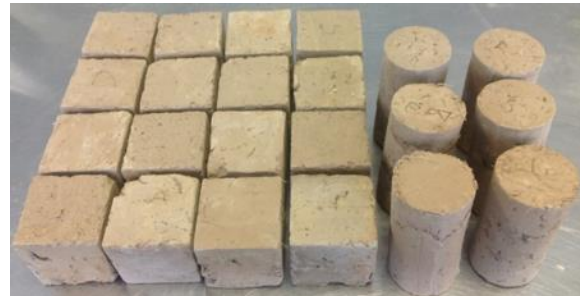
Soil, 1% fibre by weight and 11.8% water (as obtained by OMC) were used for making the specimens. The soil was first measured and spread on a platform, then the fibre was measured and spread on soil and turned over and over until a uniform mixture was obtained. The required water was sprinkled on the soil-fibre mixture and turned over and again to obtain a homogenous mixture. Cylindrical specimens of 80 mm length  $\times$  40 mm diameter (Fig. 3) were prepared by placing 200 g of the mixture into a cylindrical mould with 40 mm internal diameter and 125 mm length and quasi-statically compressing at 10 MPa pressure to a length of 80 mm, using a close fitting piston with a Tinius Olsen H50KS. These specimens were used to find out the distribution of the fibres in the soil matrix. 50 mm cube specimens (Fig. 3) were prepared with a steel mould with internal

dimension  $50 \times 50 \times 50$  mm and compressed at 10 MPa pressure with a Tinius Olsen H50KS. One mould was placed on the other which allowed the mixture to be placed in and compressed to 50 mm with a wooden plate on top. The cubes were used to determine the gaps between the fibres and the soil matrix. All the specimens were dried in fan assisted Genlab electronic oven at a temperature of  $40^\circ\text{C}$  for five days when the mass stabilised.

Fig 3: Cube and cylindrical specimen
