# **Causes of Failure and Collapse of Building Structures in Cameroonian Cities**

ABSTRACT. The phenomena of failure and consequent collapse of building structures in Cameroonian cities is so common that it has become a serious concern to the professionals in the building industry, clients, governments, and general public. In most cases, the architects and engineers who are directly involved in the construction of such building are held responsible for building collapse. This paper is intended to find out the causes of building failure and collapse in Cameroonian cities. Based on personal experience of the authors and also data collected through academic journals, conference proceedings, media reports, internet, and previous works of other authors on the subject matter, the reasons or causes of failure and collapse of building structures in the country are: Use of sub-standard construction materials or use of low quality building materials, wet-dry cycling, use of quacks or artisans, neglect of design and non-possession of approved drawings or nonpossession of building permits, inadequate preliminary works which include inadequate site investigation and foundation, the lack of fol

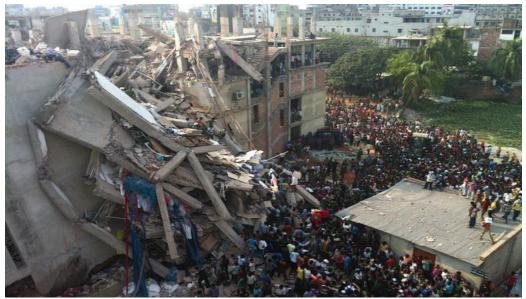
Figure 1. The collapse of Rana Plaza textile factory building [BOA 18]

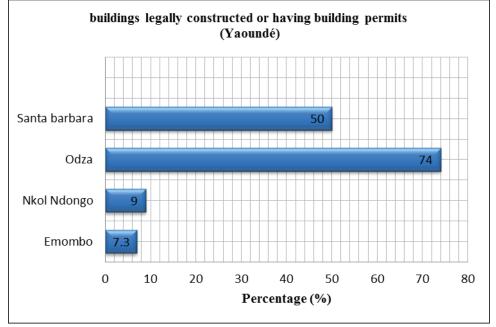
**Figure 4.** Percentages of buildings legally constructed or having building permits in certain suburbs in the city of Douala [TCH 16]

(Architect and/or Professional Engineer), i.e. more than 80% of the population accommodated. Figure 2 and Figure 3 show respectively that the Emombo neighborhoods in Yaoundé and Bépanda in Douala are the poorer neighborhoods where housing supply is the poorest and the percentage of buildings lacking building permits or administrative documents is the highest.

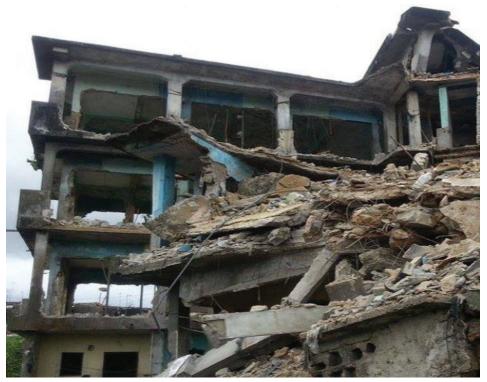
**Figure 5.** Collapse site of a 4-storey building at Nkoldongo, Yaoundé due to design errors <u>http://fr.africanews.com/2016/06/20/cameroun-cinq-morts-dans-l-effondrement-d-un-immeuble/</u>

- Inadequate preliminary works which include inadequate site investigation and foundation.
- The lack of follow-up by the local authorities after the issuance of the building permit
- Constructions in swampy areas
- Heavy rain
- Design errors/Faulty design (Figure 5)
- Erosion (Figure 6)
- Cavitation
- Abrasion
- Lack of qualified supervision and unused equipment at building sites

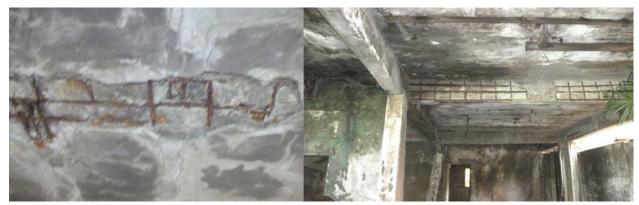
• Corrosion of the reinforcement bars (Figure 7). Figure 7. Shows cracking, spalling, and brownish staining on a part of building elements in Yaoundé which are symptoms of reinforcement corrosion. The possible causes of cracking and spalling are poor workmanship during the construction phase. The corroded reinforcements at these elements is the possibly the result of their expositions to the environment (carbon dioxide attack, acidity of rain water, etc.).

Figure 7. Cracking, spalling, and brownish staining due to corrosion of the reinforcement bars
