DURABILITY OF FLAX/BIO-EPOXY COMPOSITES INTENDED FOR STRENGTHENING APPLICATIONS IN CONSTRUCTION

The present study aims at achieving a better understanding of these coupling effects on the mechanical properties of an innovative bio-composite consisting of a bio-based epoxy matrix reinforced by flax fibers.

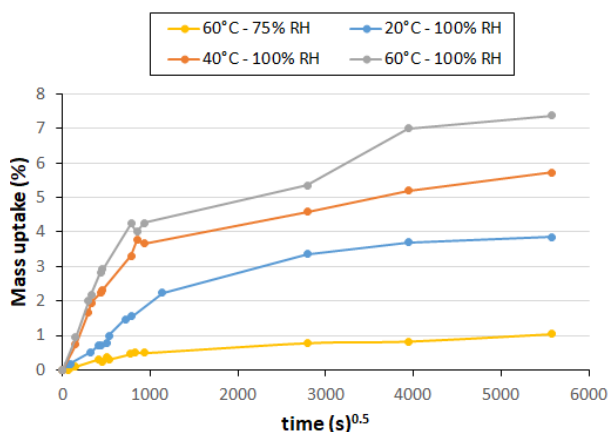
Fig. 2 shows mass uptake evolution curves over 12 months for FFRP laminates subjected to the different ageing environments, with the exception of conditions at 20°C-50% RH, 60°C-50% RH and outdoor exposure for which no significant mass change was observed.

Although sorption curves show initial linear evolutions, they do not reach a plateau at longer times and rather follow an asymptotic trend. This feature suggests that sorption process is not controlled by pure Fickian diffusion. Furthermore, as expected, humidity and temperature levels both play major roles in the sorption kinetics, as the initial slope of the curve increases significantly when one of these two factors is raised. Besides, large water uptakes are obtained with 100% RH conditions (up to 7.4% mass gain at 60°C after 12 months ageing). This result shows that FFRPs are prone to extensive water ingress when exposed to moist or wet environments. Water absorption may thus be a driving factor in the degradation of the mechanical performances of both the laminate and its adhesive bond with concrete during wet ageing. This point will be investigated in the next sections.

Fig. 2: Mass uptake versus $(time)^{0.5}$ for FFRP laminates subjected to the various ageing conditions.

Water sorption kinetics was linked to the humidity level of the ageing environment and was also found to be accelerated by temperature. Micrographic observations showed significant swelling of the flax fibers for specimens immersed at 20°C compared to reference samples, but contrarily, a reduction of the fiber section was noticed after immersion at 40 and 60°C, suggesting an alteration of the internal structure of flax fibers. Anyway, large water ingress observed under immersion at elevated temperature was assigned to the sorption process within the bio-epoxy matrix and interfacial areas, and to micro-cracking of the matrix entrapped in fiber bundles, as revealed by X-ray tomography.

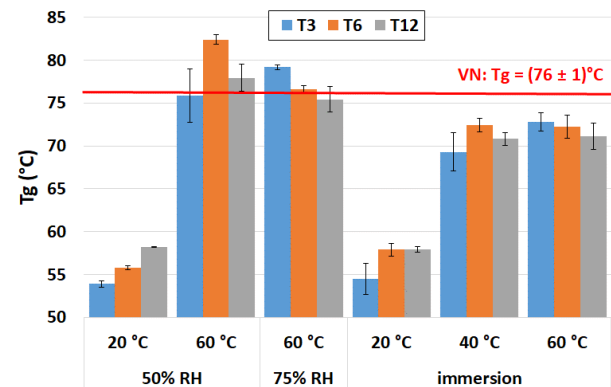
Fig. 3. reports values of the glass transition temperature (T_g) measured by DSC on FFRP laminates aged in the various environments for periods of 3, 6 and 12 months.

T_g of the specimen exposed to weathering conditions (VN) for 12 months is depicted by the red line.

Fig. 3: T_g of FFRP laminates after exposure from 3 to 12 months (T_3 to T_{12}) in the various ageing conditions. Red line corresponds to T_g level after 12 months outdoor exposure (VN).

Reference T_g value measured for the unaged laminate cured for 3 weeks at room temperature was $55.0 \pm 0.5^\circ\text{C}$. Such a low T_g is characteristic of an under-cured state of the polymer matrix, in which the polymerization process didn't reach completion.

From Fig. 3, it is found that T_g of the specimen aged at 20°C under moderate humidity (50% RH) increases slowly over time, without overpassing 58°C after 12 months. This is due to the very slow reaction kinetics of residual monomers at this temperature. A similar trend is observed at 20°C under immersion, for the same reason.

Exposure to 60°C under moderate humidity (50% RH) leads first to a very large increase in T_g during the first 6 months (up to 82°C), followed by a slight decrease over the next 6 months. The first increase can be assigned to the post-curing process of the polymer matrix, as the elevated temperature facilitates the diffusion of unreacted monomers and promotes further crosslinking of the thermoset network. In the second stage, the decay may result from oxidation induced degradation (to be confirmed by FTIR analyses).

Ageing at 60°C and 75% RH leads also to a sharp increase in T_g during the first 3 months, followed by a decay after 6 and 12 months, which may relate to the effect of humidity through a plasticization process. Oxidation-induced degradation may also be involved at long ageing times.

Regarding samples immersed in water (100% RH) at elevated temperatures (40 and 60°C), an initial T_g increase is also observed during the first 3 months due to post-cure (the higher the ageing temperature, the higher this T_g increase). However, such an increase remains limited compared to that obtained at 60°C under moderate or intermediate humidity levels (50 and 75% RH). This result suggests that, under wet environment, the evolution of T_g may be controlled by both the post-cure process and the plasticization by water, which have opposite effects on T_g [14-16]. At longer times (12 months at 40°C and 6 months at 60°C), a decreasing variation of T_g is observed again, suggesting that plasticization effect becomes predominant.

A very interesting feature is that T_g measured on specimens exposed for 12 months to outdoor conditions is about 76°C (very close to T_g value obtained after 12

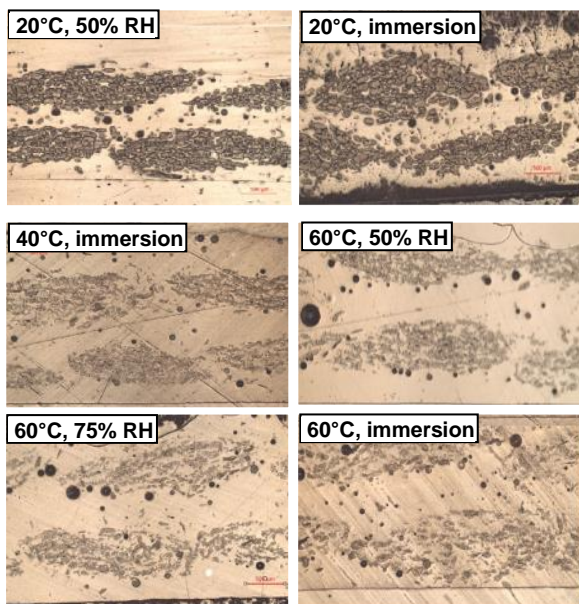
Fig. 4 displays pictures of specimens aged for 3 months in the various environments. Two main features are revealed by these images:

- First, a variation of the apparent section of flax fibers can be noticed, depending on the ageing conditions. An increase in the fiber section is observed for laminates subjected to 20°C in immersion compared to those stored at 20°C-50% RH, which can be assigned to the swelling of flax fibers induced by water absorption. Differently, specimens exposed to elevated temperatures show reduced fiber sections compared to those stored at 20°C, whatever the level of relative humidity. This may result from a modification of the fiber structure, which is not clearly identified at this stage (collapse of the internal hollow structure, extraction of soluble components?). Nevertheless, it suggests that for FFRP composites immersed at high temperature, the extensive sorption process evidenced in Fig. 2 results from water absorption by the polymer matrix and interfacial areas, and not by the fibers themselves.

- Besides, lightening and change of colour of the flax fibers (which turns to light honey colour) are observed for FFRP laminates exposed to high temperatures.

Fig. 4: Microscopic observations of polished cross-sections of FFRP laminates after being subjected to various ageing conditions for 3 months.

Regarding the evolution of the tensile Young's modulus (Fig. 5), the increase in humidity is found to degrade significantly the longitudinal stiffness of the FRP laminates over ageing. This effect is usually accompanied by an increase in ultimate elongation. For immersed specimens, the drop of modulus can reach up to 40% after 12 months at 60°C-100% RH. Such phenomena can be assigned to a plasticization effect induced by water on the polymer matrix, and to degradations (cracks) occurring within the matrix and at fiber/matrix interfaces due to swelling of the polymer and alteration of the fiber sections, as shown previously in Figs. 4 and 5.

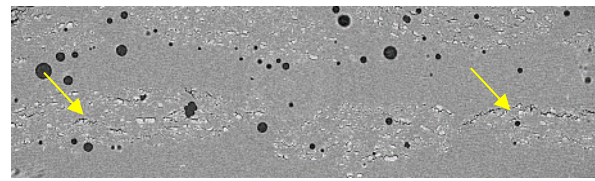
Fig. 5 presents a picture obtained by X-ray tomography of the cross section of a FFRP laminate aged at 60°C in immersion for 3 months. Cracks are clearly visible in the matrix located within the fiber bundles, which may result from swelling of the polymer matrix, or from the

“shrinkage” of the fibers as previously noticed. These cracks are not observed for specimens stored at 50% and 75% RH.

Fig. 5: X-ray-tomography picture of the cross section of the laminate aged for 3 months at 60°C in immersion.

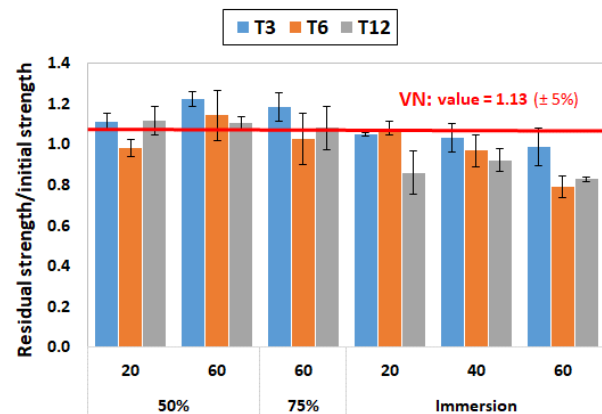
Fig. 4 and Fig. 5 report the normalized residual tensile properties (residual strength and modulus, respectively) obtained for FFRP laminates subjected to ageing periods up to 12 months in the various environments.

Fig. 4: Normalized residual strengths of specimens that were exposed to the various ageing conditions for periods up to 12 months. (T3, T6 and T12). The red line shows the value of the specimen exposed to weathering conditions (VN) for 12 months.

Regarding the tensile strength (Fig. 4), FRP composites didn't show any degradation after 3 months ageing, and a significant increase was even observed for specimens exposed to the temperature of 60°C at 50% and 75% RH, which was explained by the post-curing process of the bio epoxy matrix as previously evidenced by DSC analyses. Between 3 and 12 months ageing, specimens immersed in water show a 20% reduction of their residual strength, with a kinetics that is dependent on ageing temperature (the higher the temperature, the higher the degradation kinetics). This feature can be correlated to the water sorption kinetics, which is also temperature dependent as shown previously in section 3.1.

Specimens exposed to outdoor conditions for 12 months exhibit a slight increase in tensile strength compared to the reference, probably due to the post-cure effect evidenced by DSC.

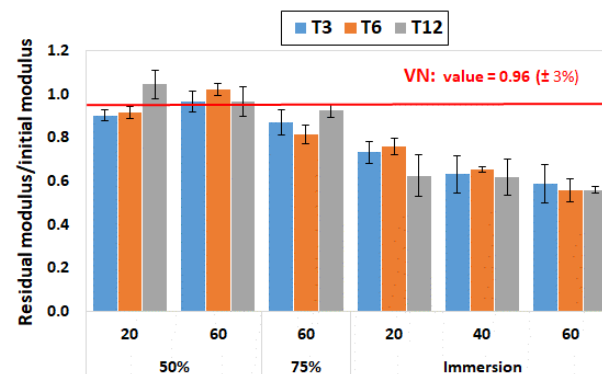
Fig. 5: Normalized residual modulus of specimens that were exposed to the various ageing conditions for periods up to 12 months (T3, T6 and T12). The red line shows the value of the specimen exposed to weathering conditions (VN) for 12 months.

An interesting point is that natural ageing (12 months exposure to outdoor conditions) does not affect the stiffness of the FRP laminate significantly, differently from what is observed with accelerated ageing tests, especially under immersion. This result suggests that immersion conditions are very severe compared to natural ageing.

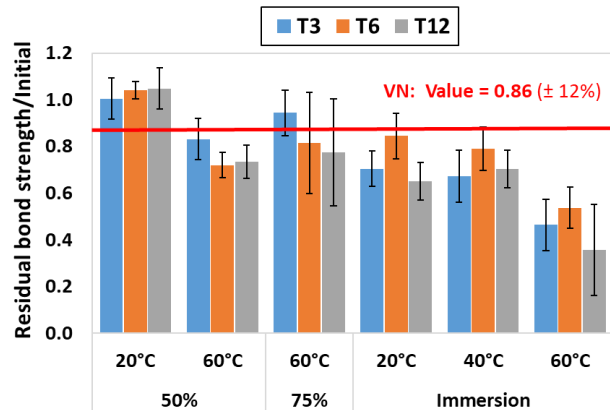
Residual pull-off strength determined on specimens aged in the various accelerated conditions over periods from 3 to 12 months (T3 to T12) are then displayed in Fig. 6. Values are normalized by the reference value, i.e. the mean pull-off strength of unaged specimens.

Fig. 6: Normalized residual bond strength between FRPs and concrete after exposure to the various ageing conditions for periods up to 12 months. The red line shows the value of the specimen exposed to weathering conditions (VN) for 12 months.

A significant decrease in bond strength was observed for all specimens, with the exception of those stored at 20°C-50% RH. Moreover, samples directly immersed in water were the most affected, with a reduction up to 50% in the case of samples subjected to 60°C-100% RH, which is also consistent with the large water uptake evidenced for FRP composites in these conditions (Fig. 2). Such a degradation of the bond strength under wet conditions was accompanied by a change in failure mode, from an initial cohesive concrete failure towards a mixed failure mode (Fig. 7b) or FRP debonding mode (Fig. 7c) after ageing. This change in failure mode and the reduction in bond strength can both be attributed to a weakening of physico-chemical bonds at the concrete /composite interface in presence of water.

Here again, a very interesting feature is that specimens aged under natural weathering conditions (VN) for 12 months show only limited reduction of their pull-off

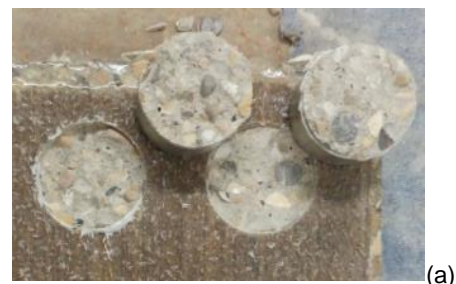
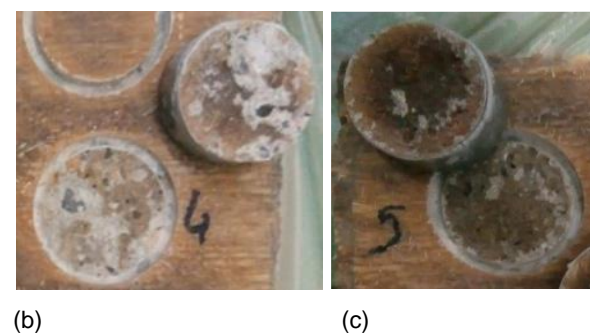
Fig. 7: Failure modes after pull-off tests - (a) initial cohesive concrete failure on unaged specimens, (b) typical mixed failure and (c) composite debonding obtained for specimens subjected to wet ageing.

Adhesive bond properties were assessed by pull-off tests. In a preliminary stage, reference properties were determined on unaged FRP strengthened concrete slabs, giving an average value of 4.09 ± 0.25 MPa for the pull-off strength and a typical cohesive concrete failure (Fig. 7.a).

strength (~14%), together with a mixed failure mode similar to that presented in Fig. 7.b. This suggests once more that natural ageing might be less severe compared to accelerated ageing by immersion in water.
